**Santiago Fire
Roads/Trails
BAER SPECIALIST REPORT**

Cleveland National Forest	November 10, 2007
Assessment by:	(Corrected Version, Nov. 19, 2007)
Mike Bradshaw	
Supervisory Civil Engineer	
Stanislaus National Forest

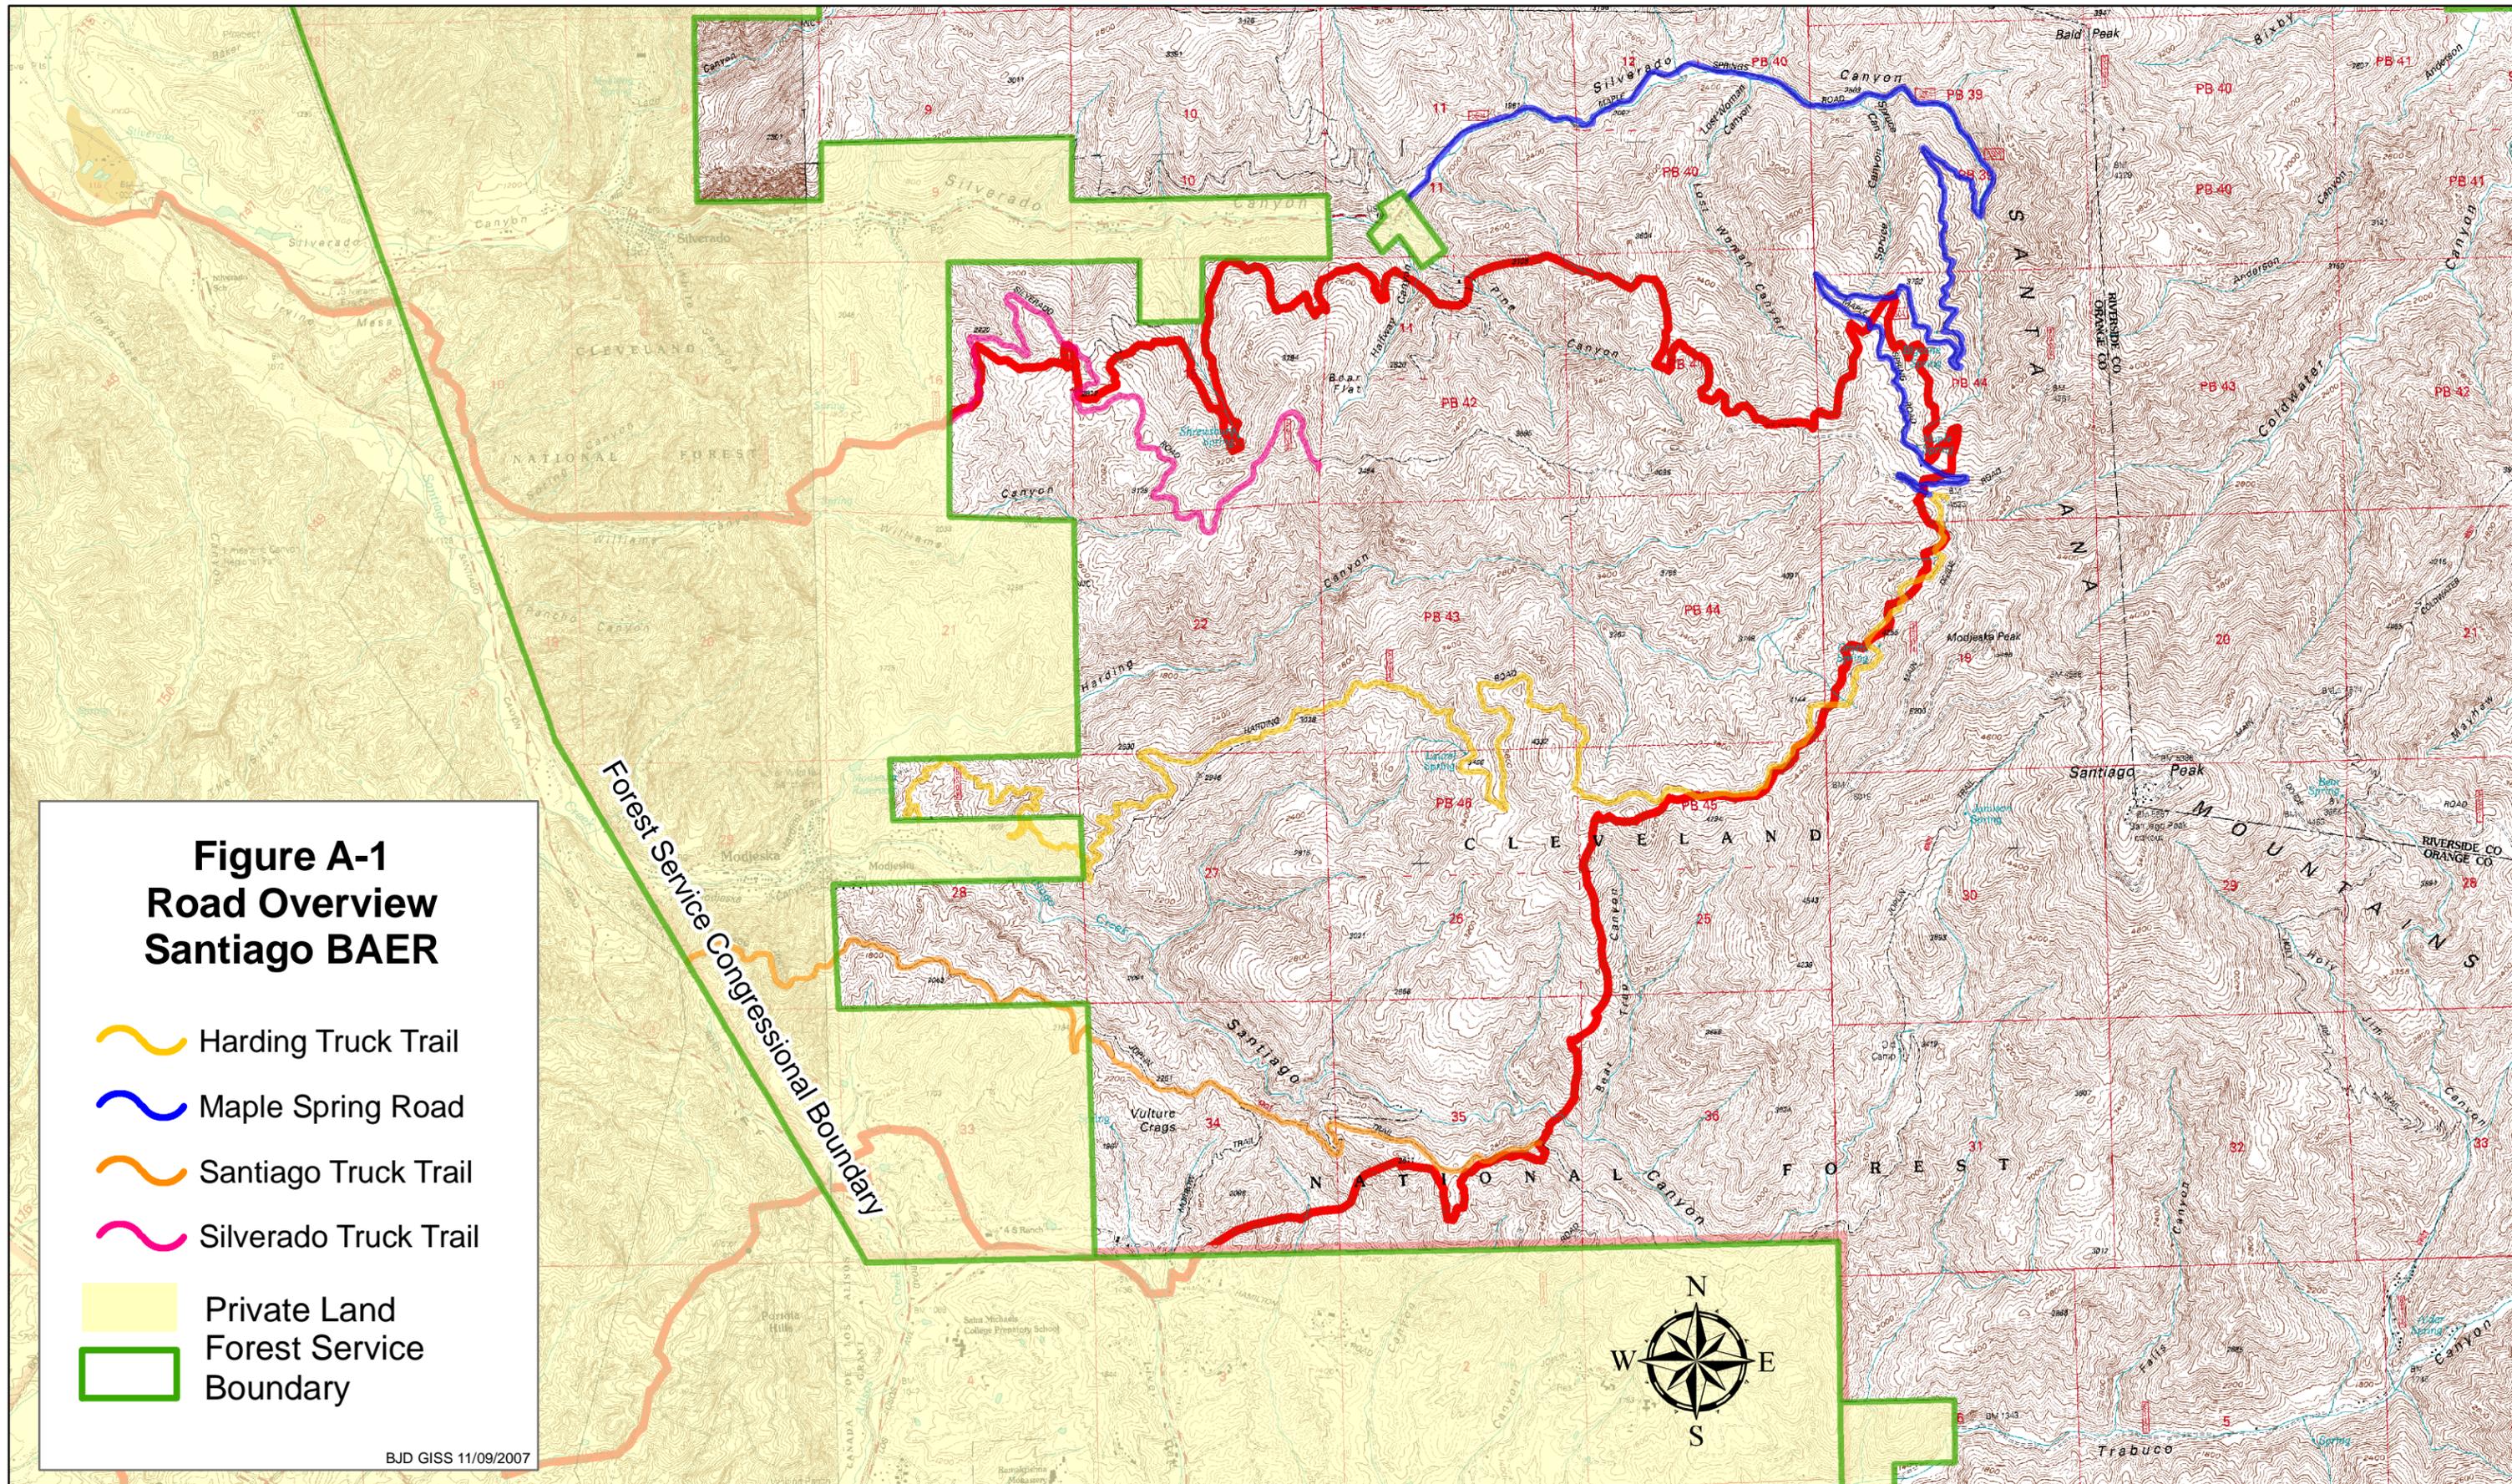
**Figure A-1
Road Overview
Santiago BAER**

- Harding Truck Trail
- Maple Spring Road
- Santiago Truck Trail
- Silverado Truck Trail

Private Land
Forest Service
Boundary

This report covers the National Forest System Roads and managed trails in the Santiago Fire area. Figure A-1 shows an overview of the NFSR roads in the fire area and Figure A-2 shows the burn severity for the fire area.

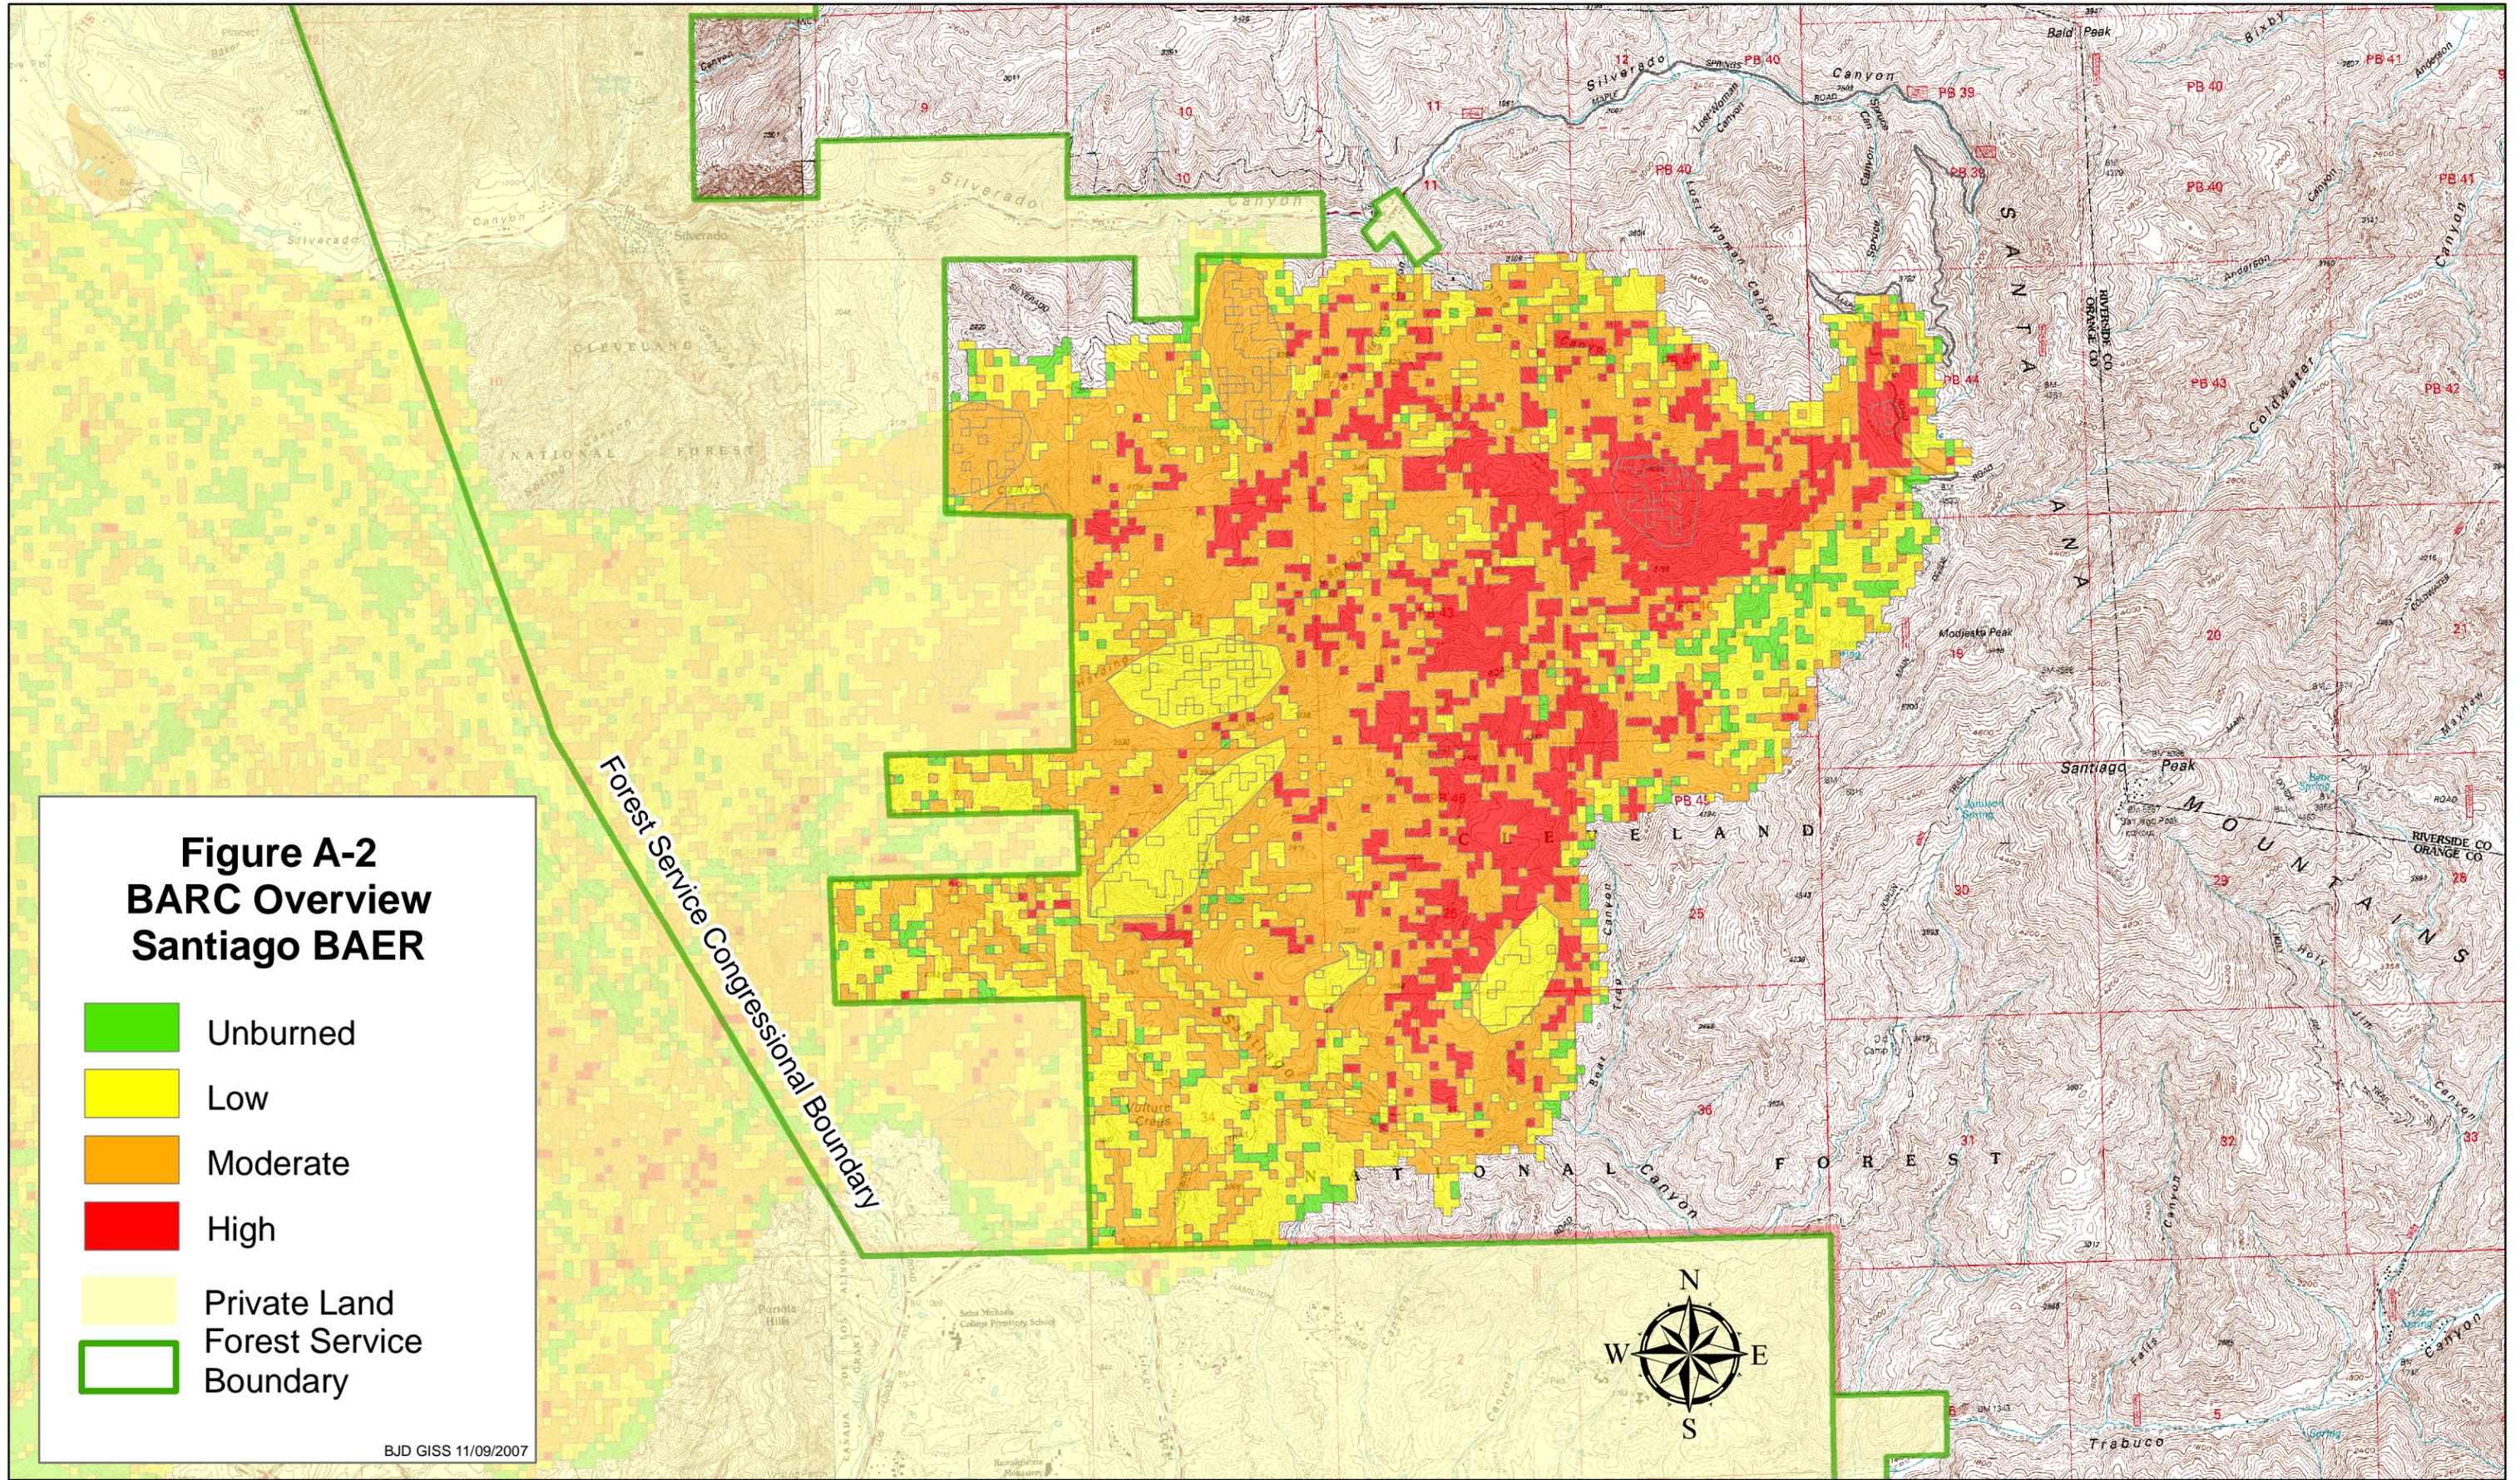
**Figure A-2
BARC Overview
Santiago BAER**

Unburned
-

Low
-

Moderate
-

High
-

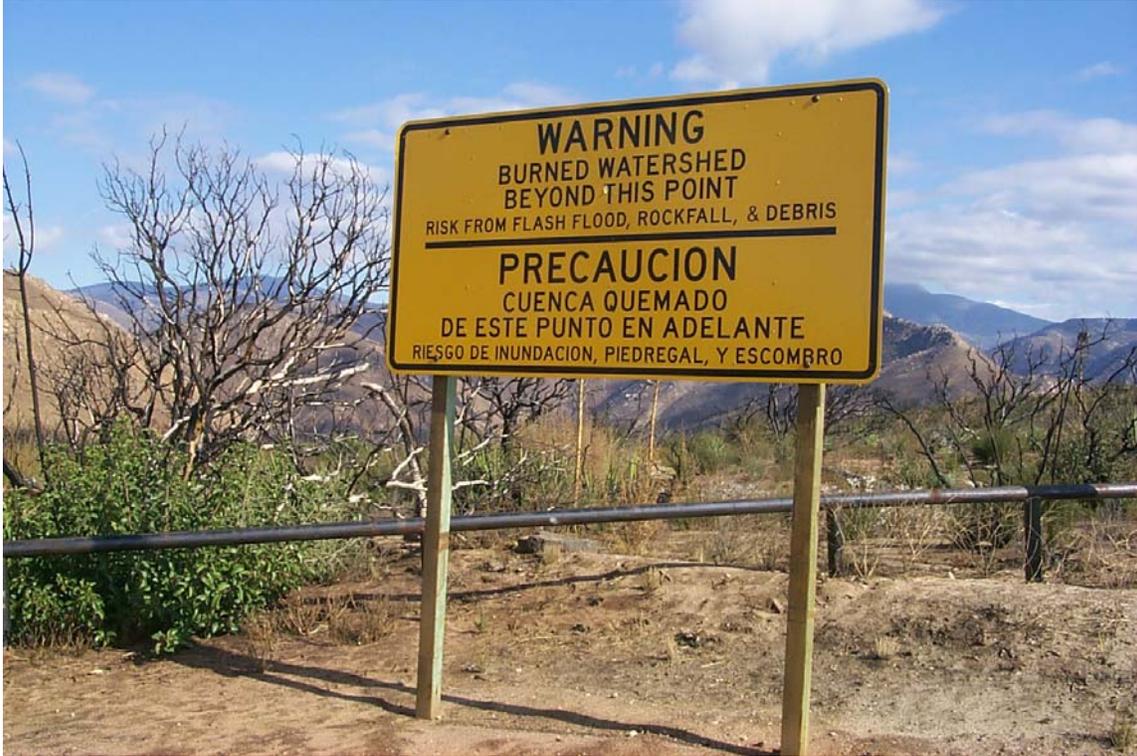
Bilingual BAER Warning Sign

Construct and install signs with text, font, colors, size and shape designated by the Forest Service at locations designated by the Forest Service. Information signs will be 18 inches by 24 inches and will provide background on reasons for closures and contact phone numbers for further information. Warning signs will be 48 inches by 96 inches, black on yellow, fabricated to MUTCD standards, and will alert the public to watershed and traffic hazards in order to minimize accidents. Sign text will be in English and Spanish. See attached examples.
