2011 LAS CONCHAS FIRE

EMERGENCY STABILIZATION PLAN

BUREAU OF INDIAN AFFAIRS

INTERAGENCY BAER TEAM

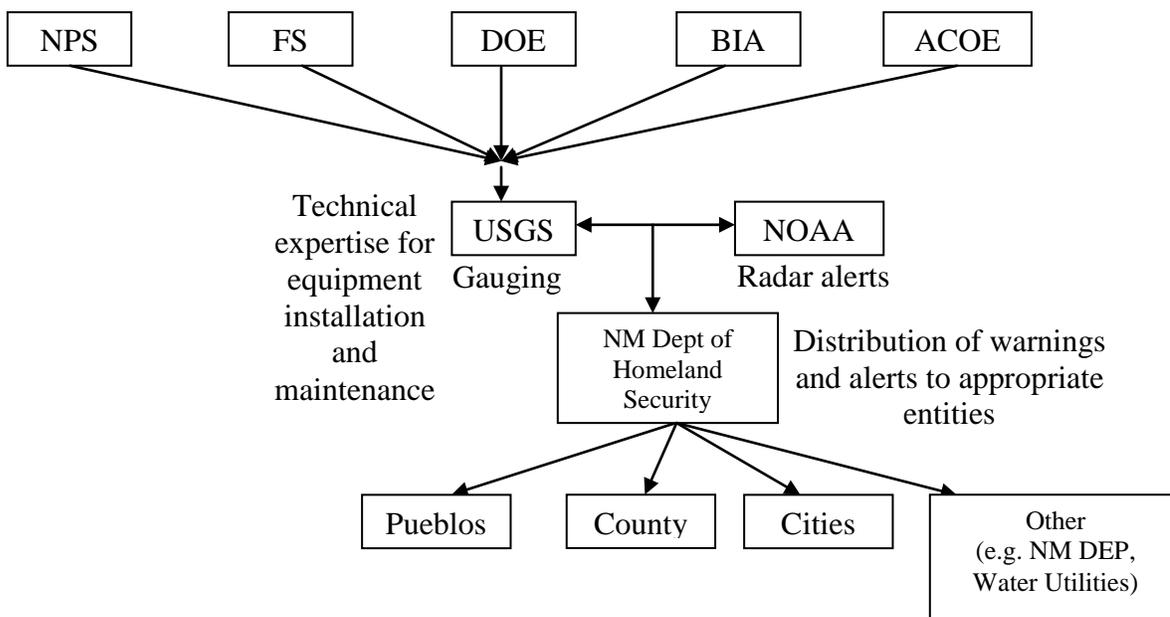
There are several homes downstream of the burn area that are at risk of increased post-fire stream flow flooding and debris torrents. Early alert systems for precipitation and stream flow can provide residents with some advanced warning of conditions that could result in these elevated flows. After the Las Conchas Fire many agencies and communities wished to install early warning systems to address the risk to life and property downstream of the burn area, especially in watersheds burned at high and moderate soil burn severity. To ensure that the systems are coordinated and appropriate warnings are given at the earliest possible time, the agencies have devised a process diagrammed below.

The main land management agencies will provide funding and land use agreements to allow the USGS, who has expertise in early alert systems, to locate, install and operate the systems. The Implementation Team Leader will work with the USGS to find the appropriate locations for the gauges. The National Weather Service will additionally utilize weather radar to provide early warning to communities. All of the warnings (radar, precipitation and streamflow) will be disseminated to communities by the New Mexico Dept. of Homeland Security. Beyond local communities additional agencies will be notified, especially water quality entities who may wish to avoid taking in water when ash and sediment levels that can damage equipment are predicted to be elevated.

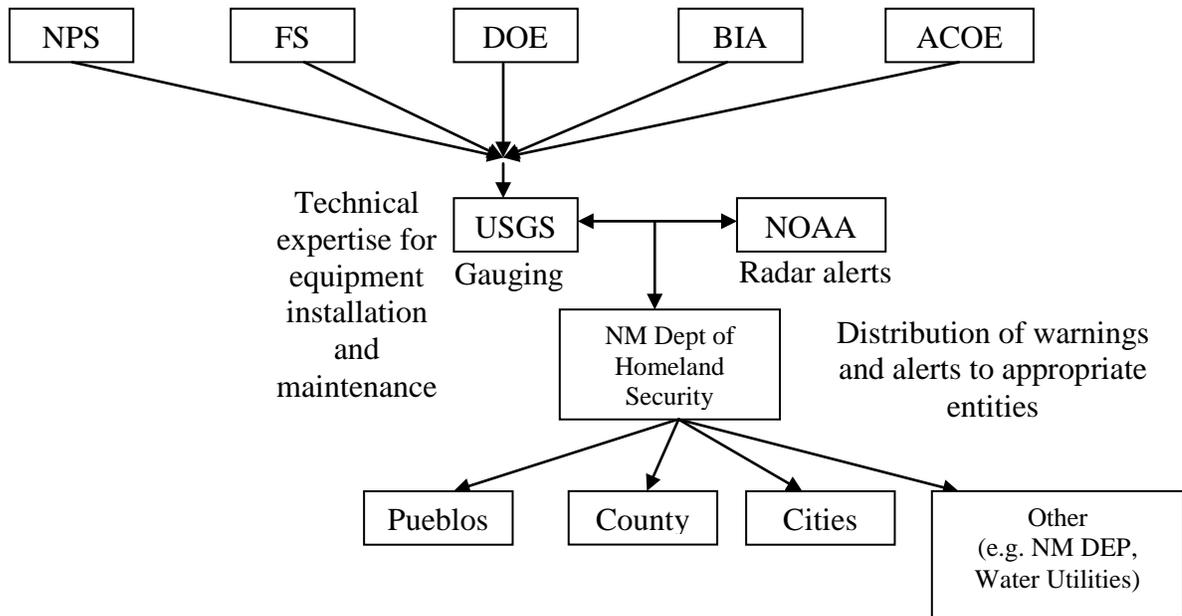
There are several homes downstream of the burn area that are at risk of increased post-fire stream flow flooding and debris torrents. Early alert systems for precipitation and stream flow can provide residents with some advanced warning of conditions that could result in these elevated flows. After the Las Conchas Fire many agencies and communities wished to install early warning systems to address the risk to life and property downstream of the burn area, especially in watersheds burned at high and moderate soil burn severity. To ensure that the systems are coordinated and appropriate warnings are given at the earliest possible time, the agencies have devised a process diagrammed below.

The main land management agencies will provide funding and land use agreements to allow the USGS, who has expertise in early alert systems, to locate, install and operate the systems. The Implementation Team Leader will work with the USGS to find the appropriate locations for the gauges. The National Weather Service will additionally utilize weather radar to provide early warning to communities. All of the warnings (radar, precipitation and streamflow) will be disseminated to communities by the New Mexico Dept. of Homeland Security. Beyond local communities additional agencies will be notified, especially water quality entities who may wish to avoid taking in water when ash and sediment levels that can damage equipment are predicted to be elevated.

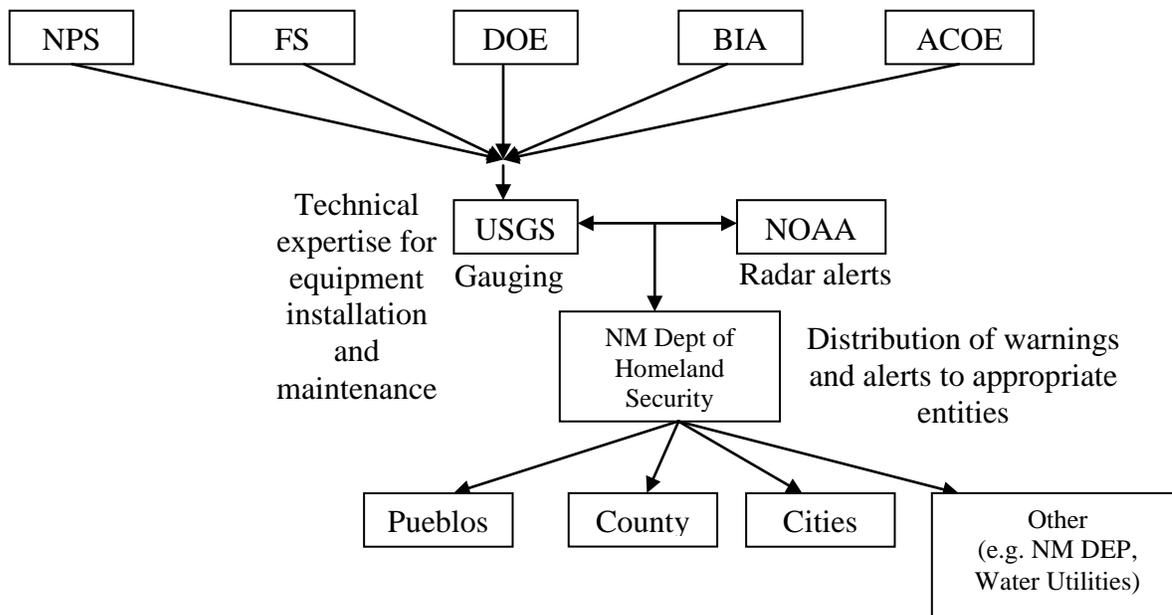
There are several homes downstream of the burn area that are at risk of increased post-fire stream flow flooding and debris torrents. Early alert systems for precipitation and stream flow can provide residents with some advanced warning of conditions that could result in these elevated flows. After the Las Conchas Fire many agencies and communities wished to install early warning systems to address the risk to life and property downstream of the burn area, especially in watersheds burned at high and moderate soil burn severity. To ensure that the systems are coordinated and appropriate warnings are given at the earliest possible time, the agencies have devised a process diagrammed below.

The main land management agencies will provide funding and land use agreements to allow the USGS, who has expertise in early alert systems, to locate, install and operate the systems. The Implementation Team Leader will work with the USGS to find the appropriate locations for the gauges. The National Weather Service will additionally utilize weather radar to provide early warning to communities. All of the warnings (radar, precipitation and streamflow) will be disseminated to communities by the New Mexico Dept. of Homeland Security. Beyond local communities additional agencies will be notified, especially water quality entities who may wish to avoid taking in water when ash and sediment levels that can damage equipment are predicted to be elevated.

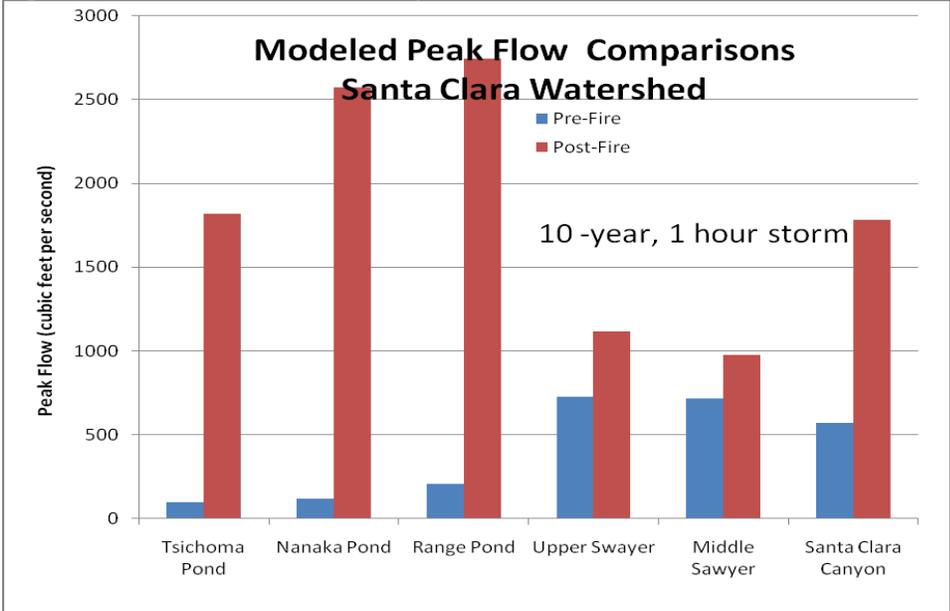
Figure 1. Modeled Peak Flow Comparisons, Santa Clara Watershed.

The effect of wildfires on storm runoff is well documented. Wildfires typically cause an increase in watershed responsiveness to precipitation events as shown in Figures 1, 2, and 3. Burned watersheds can quickly yield runoff due to the removal of protective tree and shrub canopies and litter and duff layers, thus producing flash floods. Burned areas often respond to the local storm events in a much flashier way. The amount of water yield increase is variable and it is often orders of magnitude larger than pre-fire events. These negative impacts are predominantly true in watersheds that experienced significant consumption of the shrub community and moderate to high soil burn severity effects. Fire may increase the number of runoff events as well since it generally takes a smaller storm to trigger runoff until vegetation begins to recover. Peak flow increases from the fire may also be augmented by debris flows of floatable and transportable material within the active channel areas and steep, incised drainages.

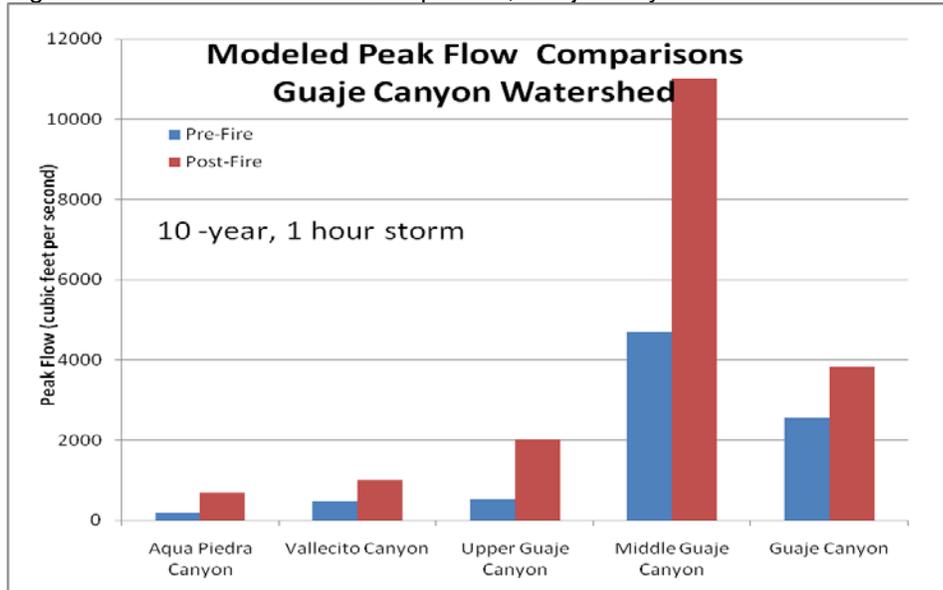
Figure 3. Modeled Peak Flow Comparison, Guaje Canyon.

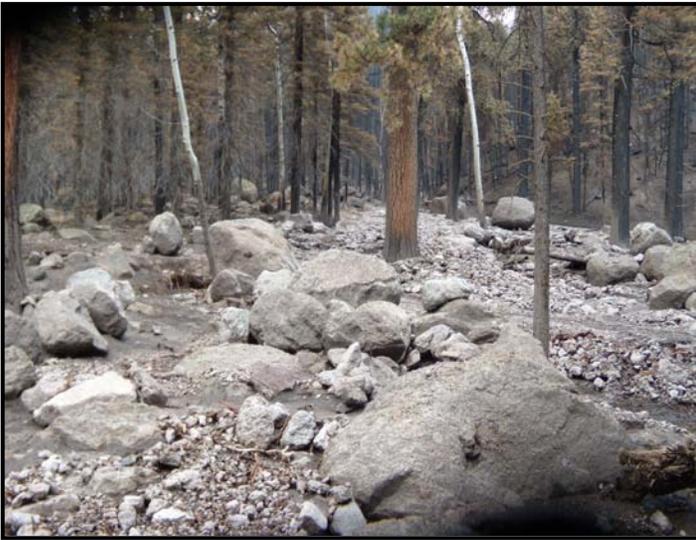
Debris Flow Damage

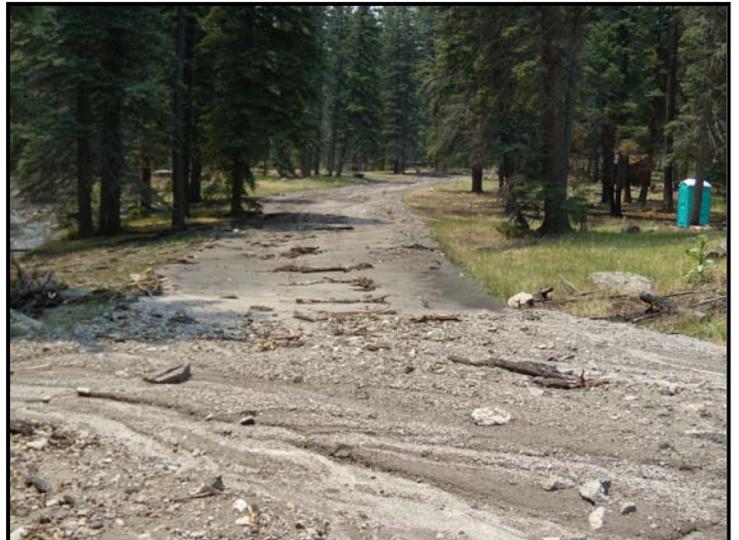
Debris Flow Damage Across Road

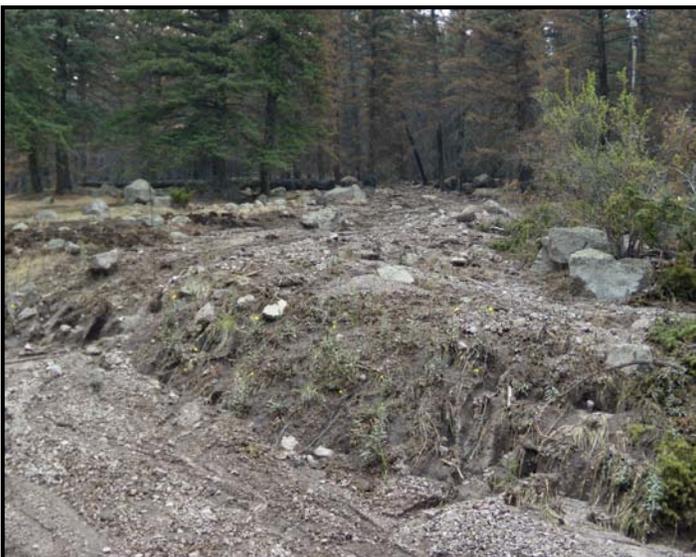
Debris Flow Damage

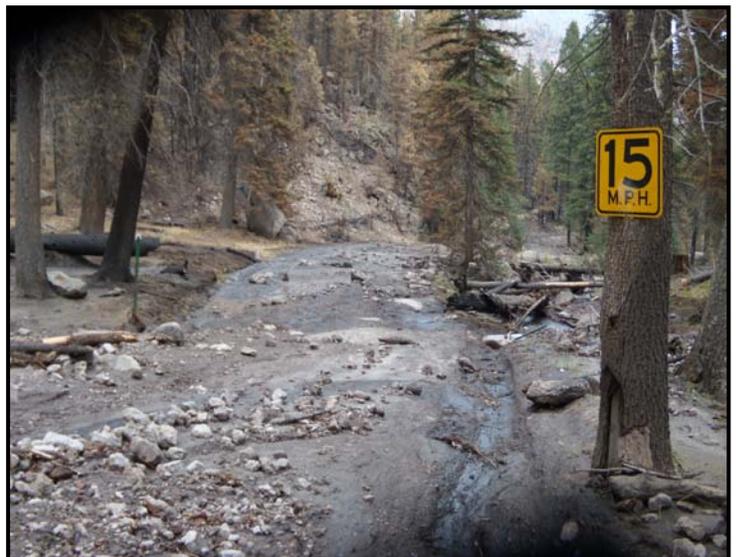
Debris Flow Damage Across Road

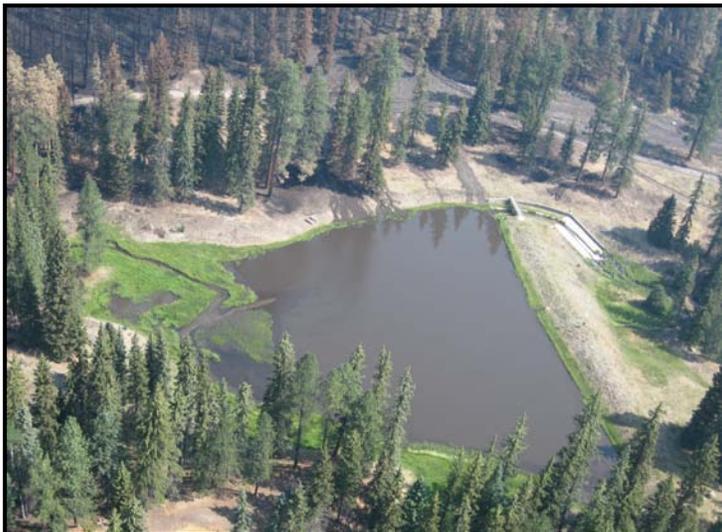
Debris Flow Entering 3rd Pond From North

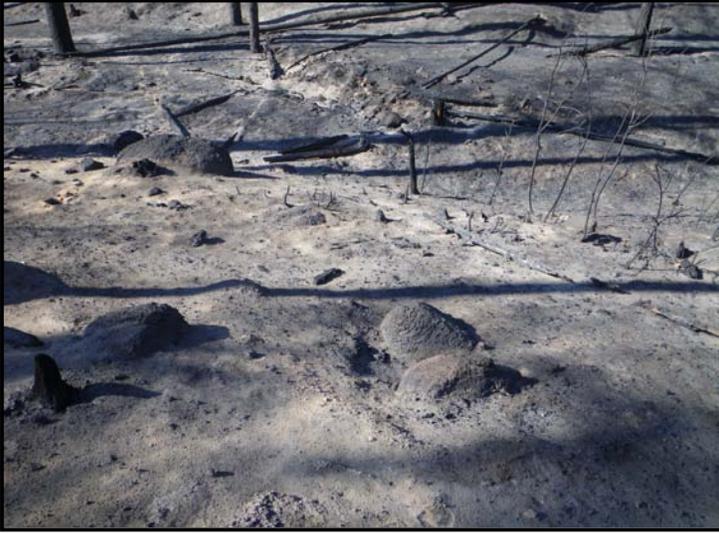
Garcia Canyon_High Burn Severity Data Point

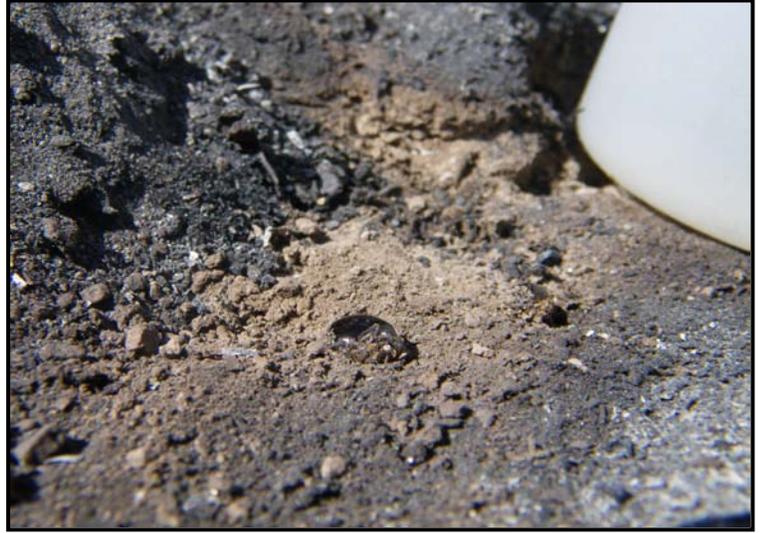
Water Repellency Test_Moderate Soil Burn Severity

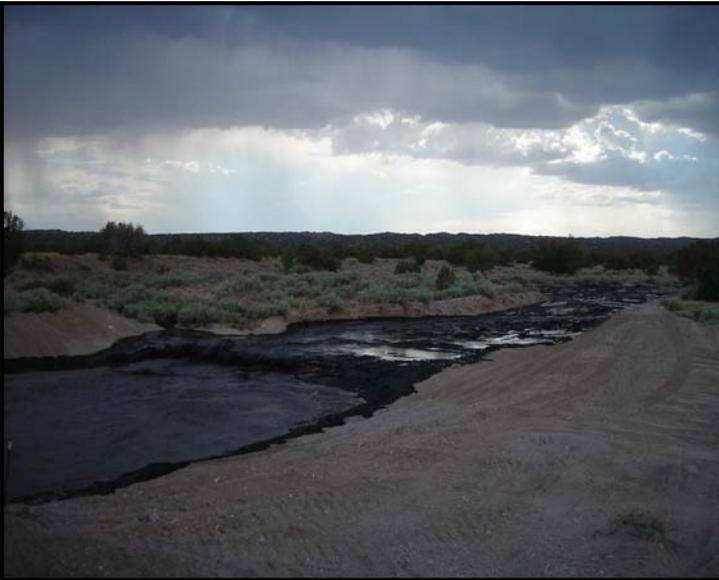
Peralta Ash Flow From Storm_7/23/2011

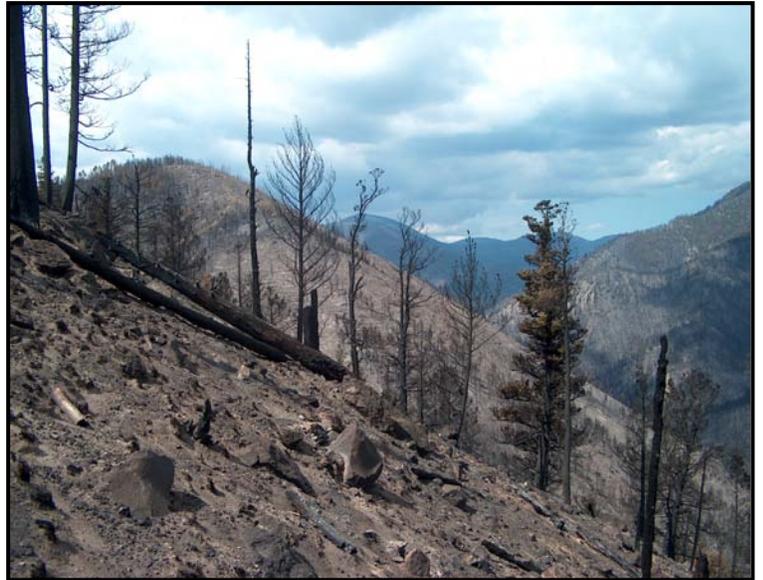
Moderate Burn Severity_Steep Slopes

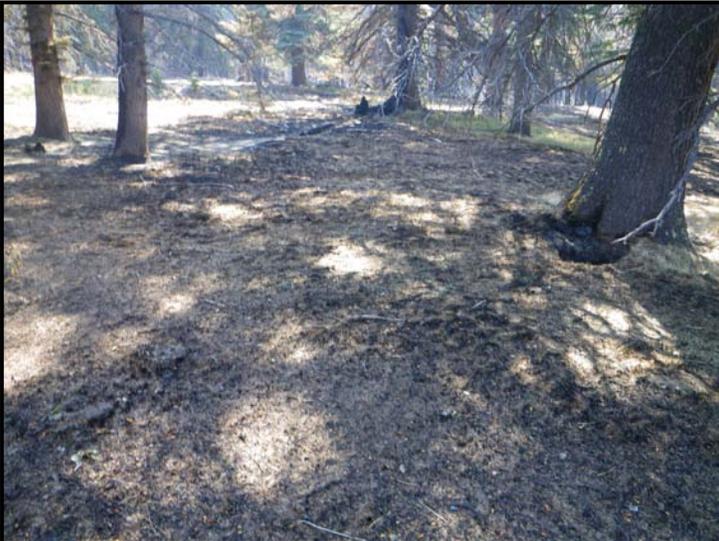
Low Burn Severity

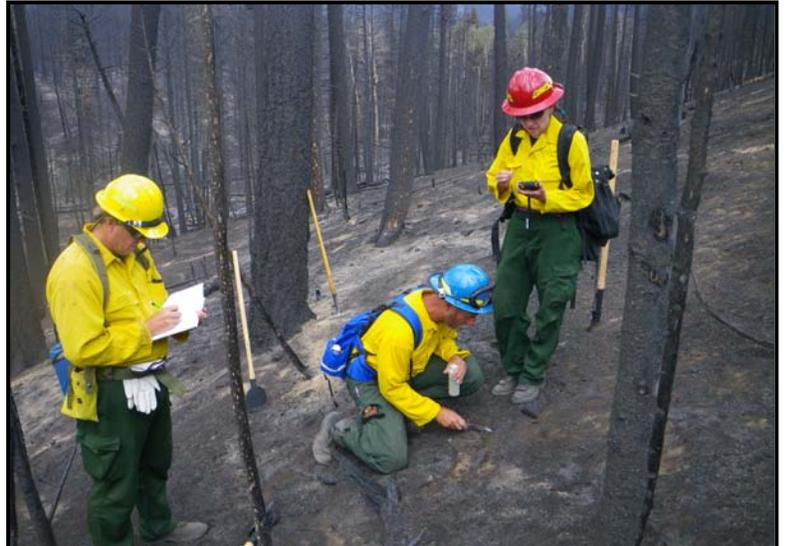
Field Work_Moderate Soil Burn Severity

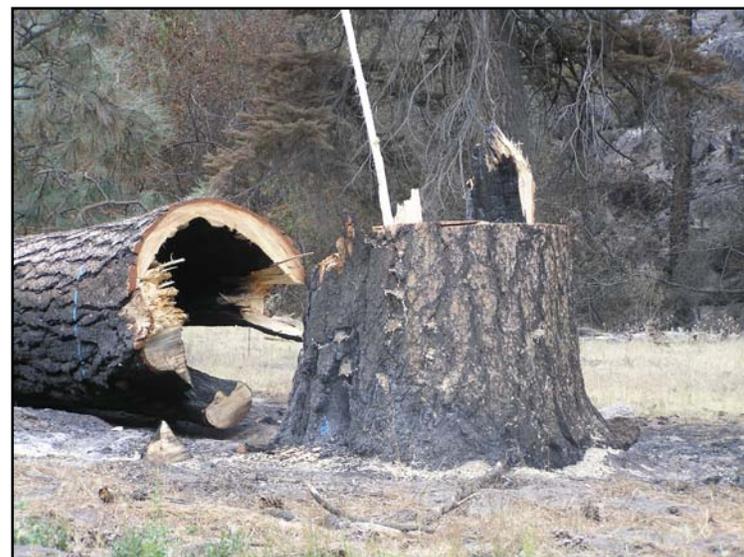
Mitigated Imminent Tree Hazard

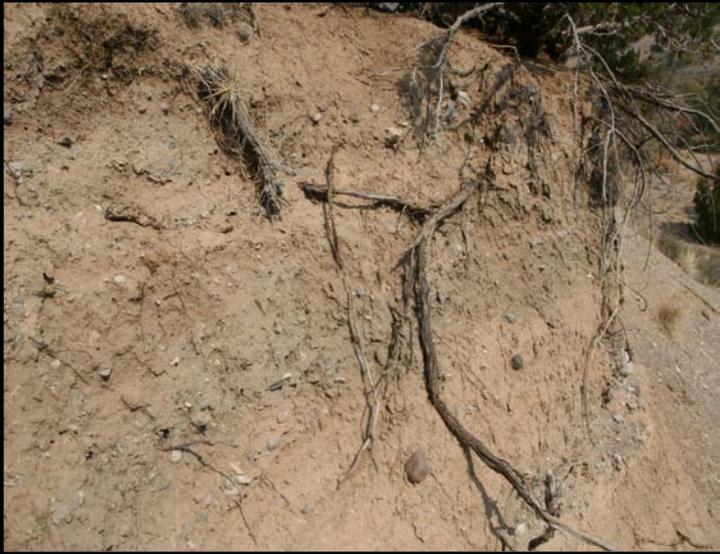
Buried Cultural Deposit Above Drainage

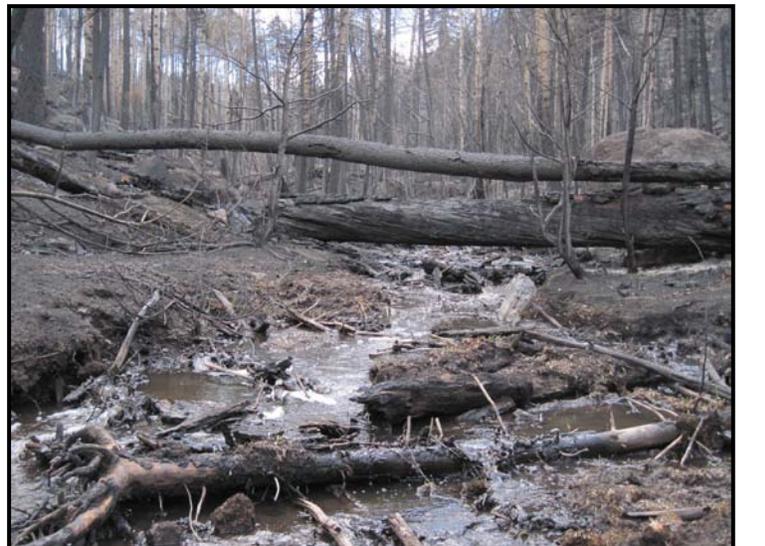
Burned Trees and Debris in Rio del Oso

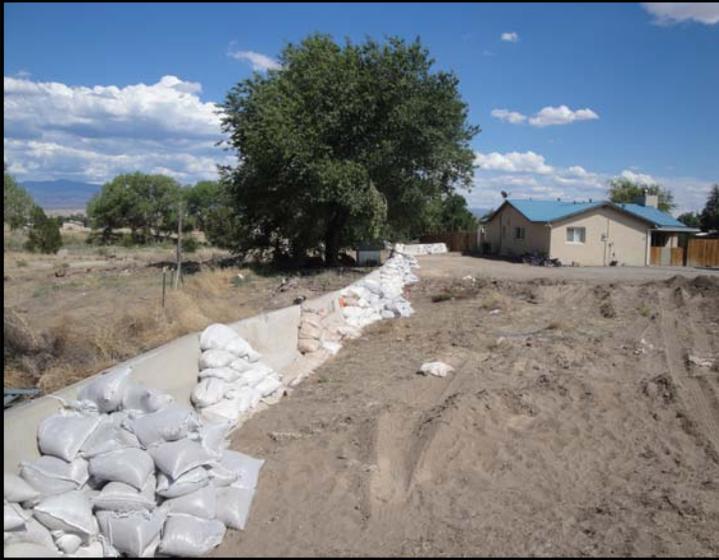
Structure Protection_Santa Clara

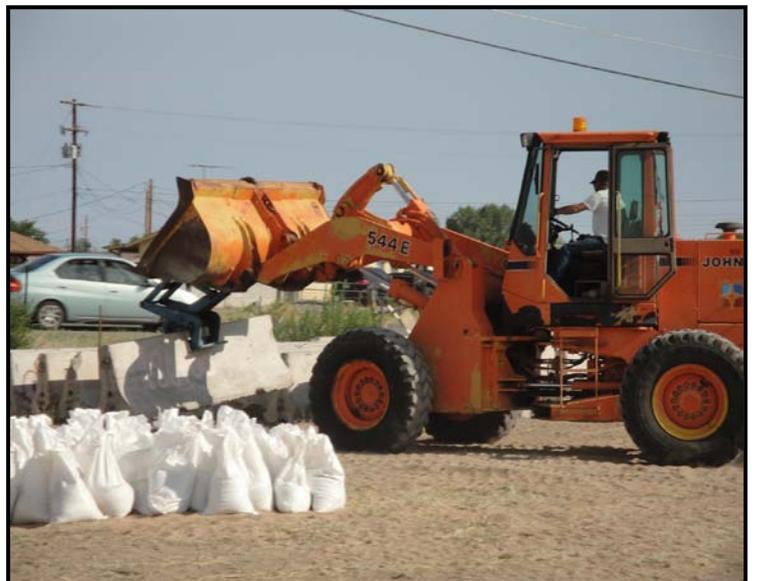
K-rail Placement_Santa Clara

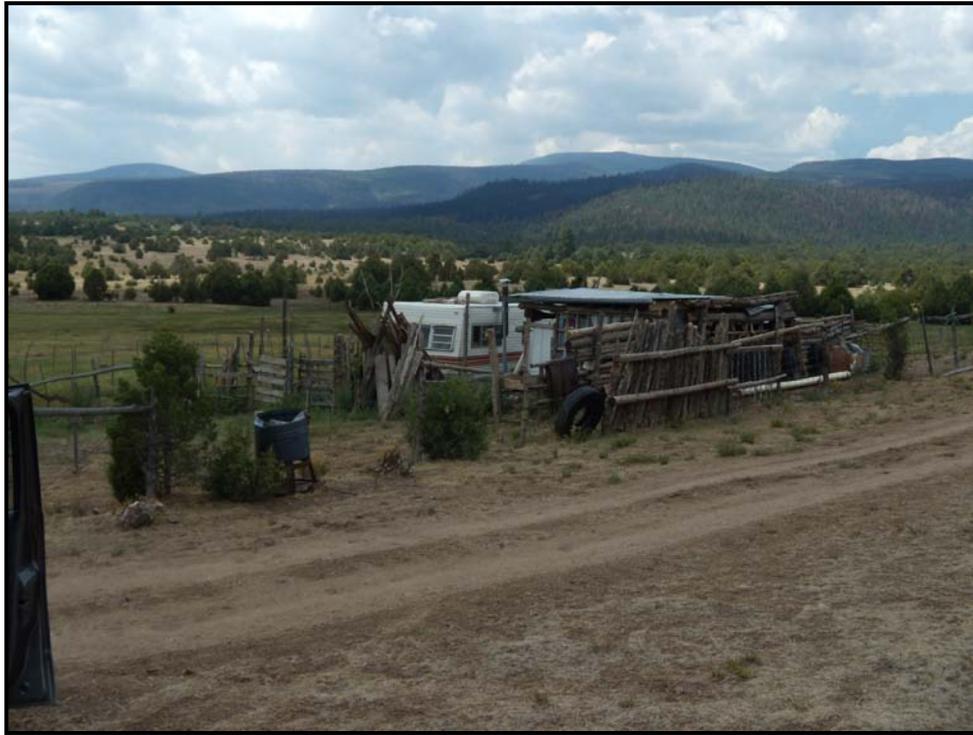
Figure 2. VAR #1. Hunting trailer near burned area. Trailer is well away and elevated above burned area drainage (background).

Justification: Two structures were identified downslope of the burned areas (Figure 1, 2, & 3) however both structures, a single room house and a hunting trailer, are positioned well above and away from the active channels downstream of the burned areas and are not at risk to flooding from post-fire watershed conditions.

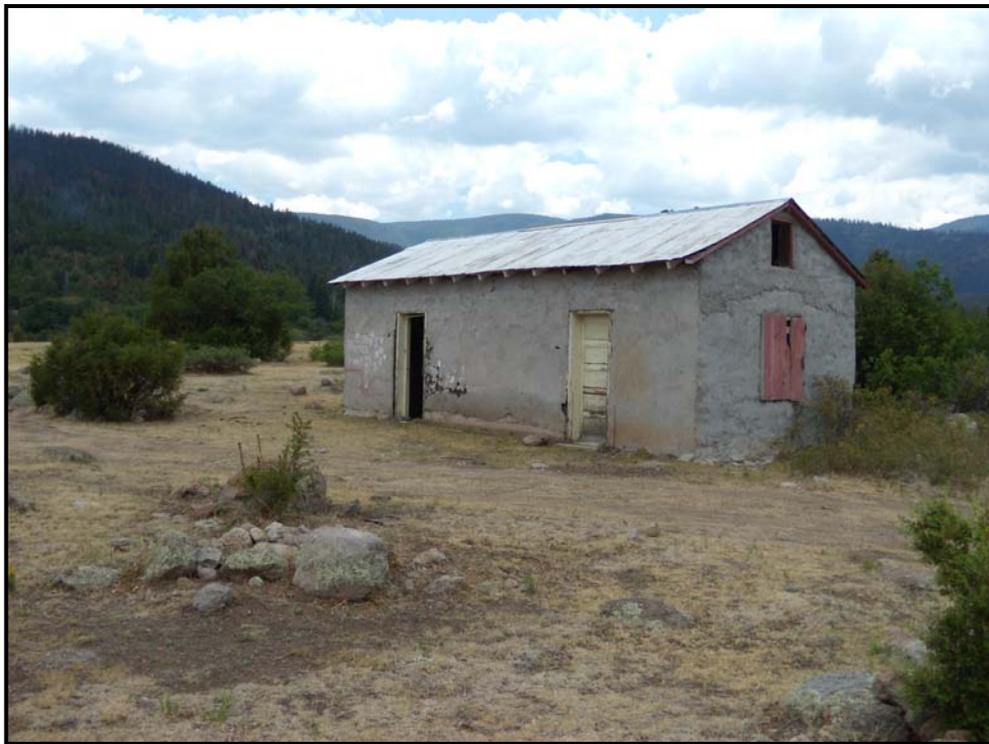
Figure 3. VAR #2. Structure near burned area. Structure is well elevated above streams within the burned area.

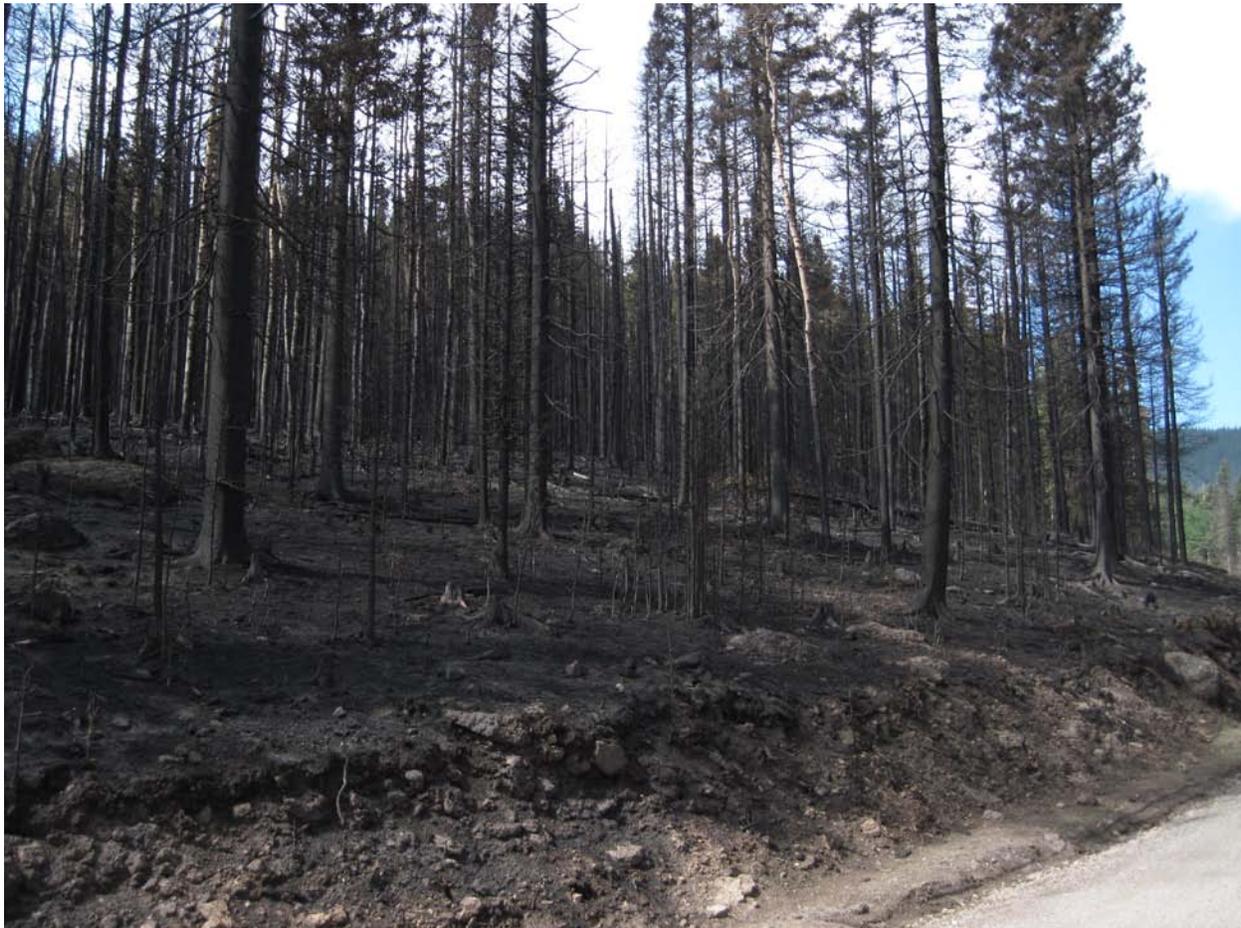
Figure 1. Burned trees along roadside in Rio del Oso Watershed

Treatment Description: After a thorough evaluation of the fire area, it was determined that there was no hazard tree potential in this section of the fire. The dirt roads in this area are rough and very remote and the trees that have died do not meet the criteria to be categorized as hazard trees. There are no structures or targets, other than the dirt roads and the vehicles that use them, where property damage or injury could occur (see Figures 1 and 2). There is the potential for salvage logging if the agency chooses to pursue that action as a management alternative.

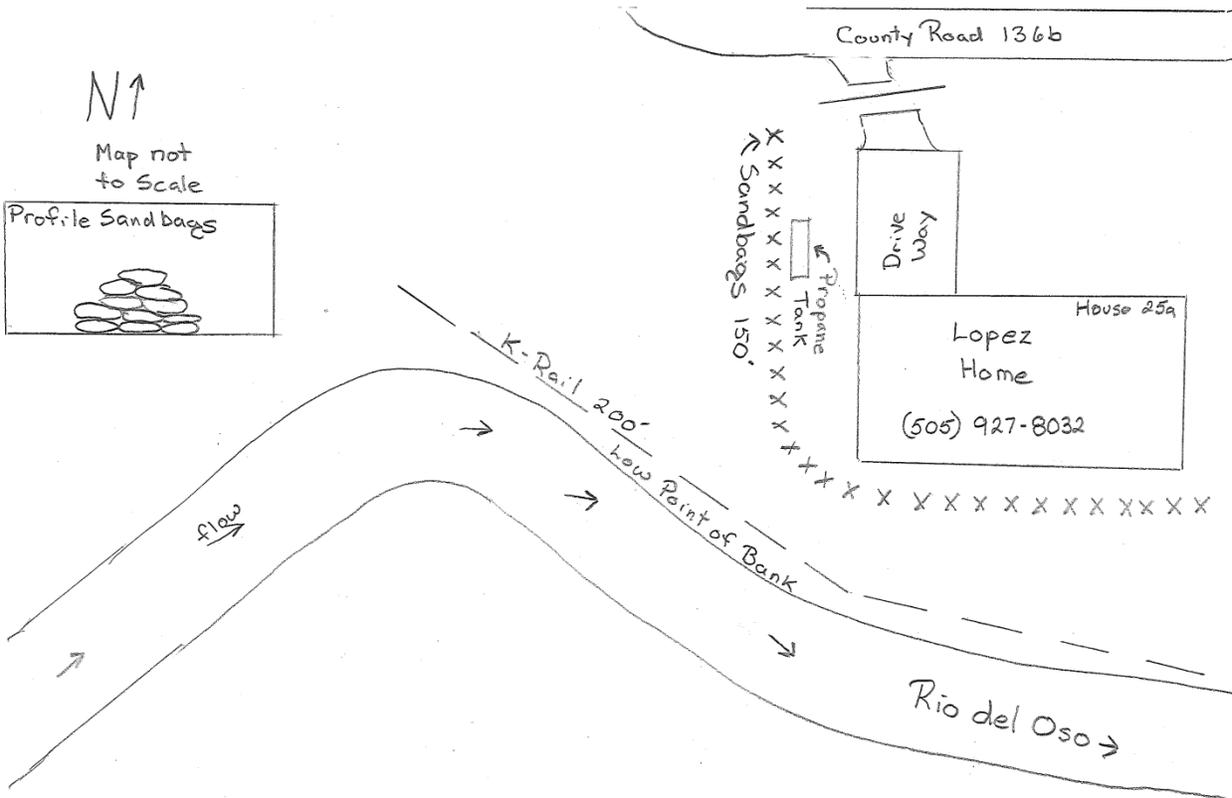
Figure 1. Treatment locations of K-Rail and sandbags along Rio del Oso and Lopez home.

Treatment Description: Place 200 feet of 20 foot long K-Rail along the north bank of the Rio del Oso and place 150 feet of sandbags (approximately 2000) around house as prescribed (Figure 1). Tie K-Rail structure to large trees with steel cable if possible. Sandbags will be placed 5 high with three wide on the base and second level, two wide on the third and fourth level, and capped with one fifth level (see map for sandbag profile). The K-Rail treatment should remain in place and the sandbag treatment should be removed in 5 years. Paint the sandbags after placement with exterior latex paint (earth-tones) to prolong lifespan of sandbag treatment. Without painting, the sandbag treatment will last only 1 to 1.5 years when exposed to sunlight in an arid climate, which is not long enough to protect the home from post-fire watershed conditions that may persist up to five years. Also recommended, the resident should raise the propane tank off of ground level to local construction standards for safety concerns.

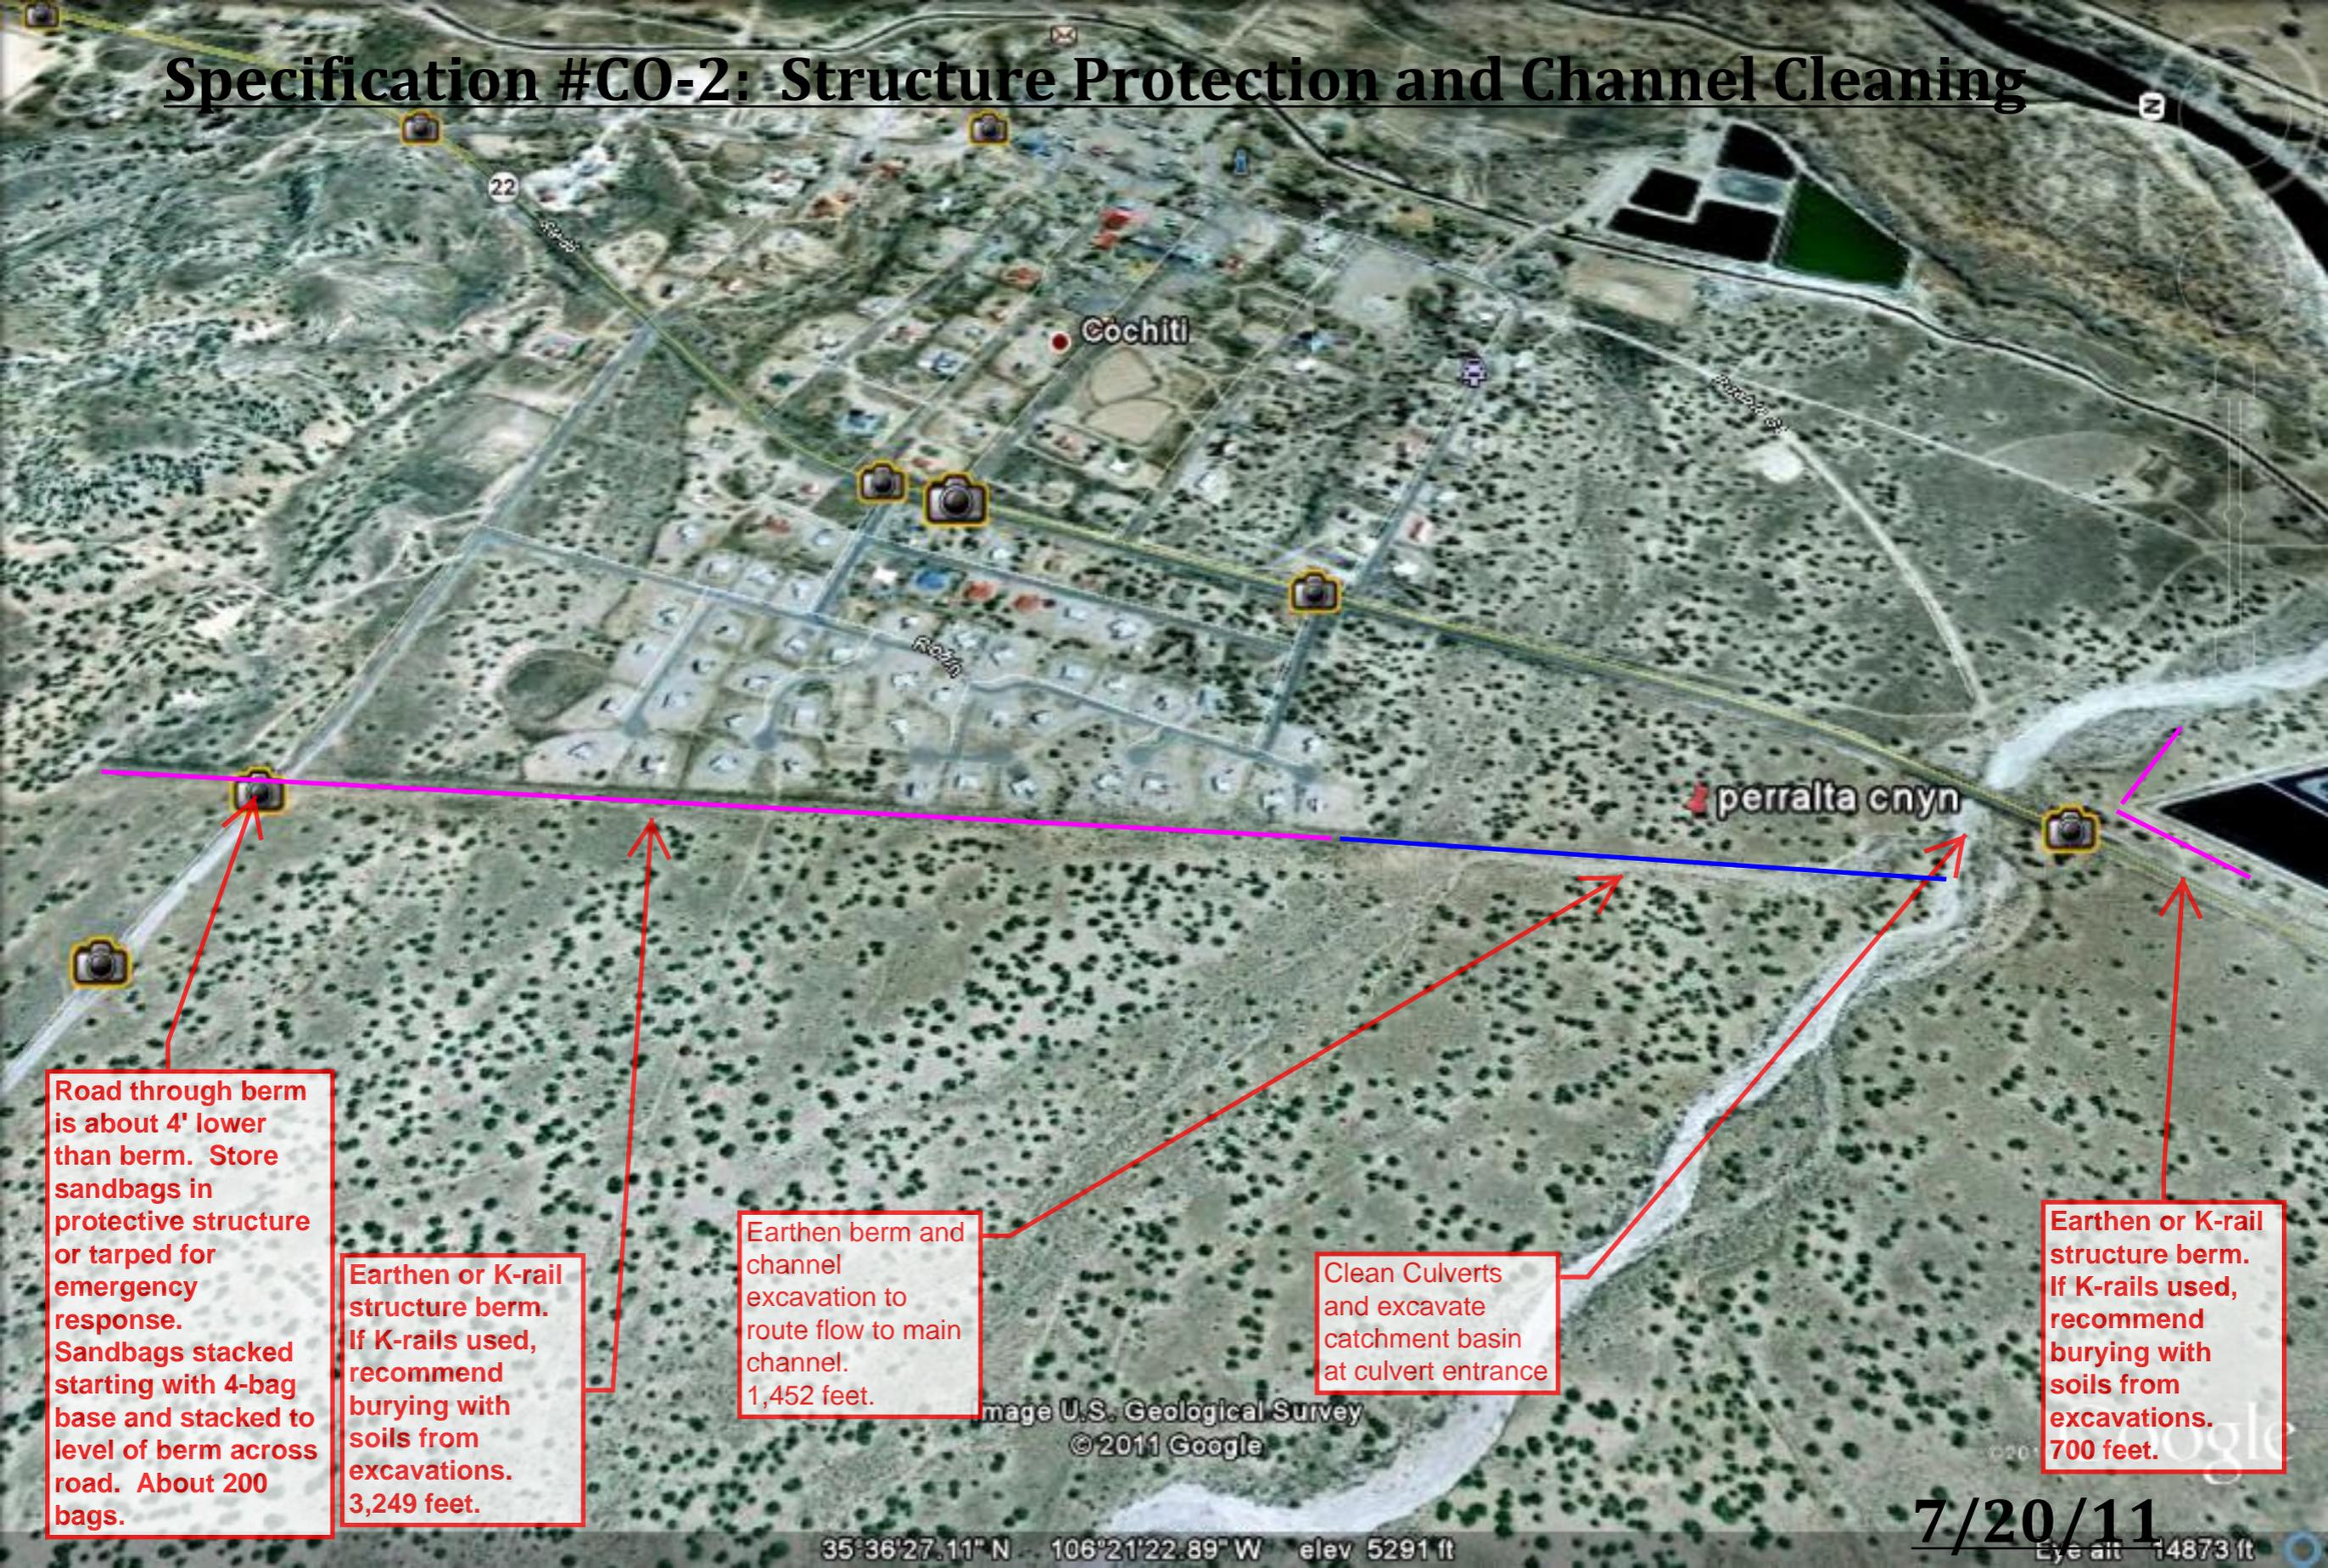
Specification #CO-2: Structure Protection and Channel Cleaning

Road through berm is about 4' lower than berm. Store sandbags in protective structure or tarped for emergency response. Sandbags stacked starting with 4-bag base and stacked to level of berm across road. About 200 bags.

Earthen or K-rail structure berm. If K-rails used, recommend burying with soils from excavations. 3,249 feet.
