**JONES FIRE**  
**OR-WIF-170191**  
**Repair Status Map**  
Datum: North American 1983  
09/30/2017  
Day Shift  
Perimeter as of: 09/27/17  
Approx:10,114ac

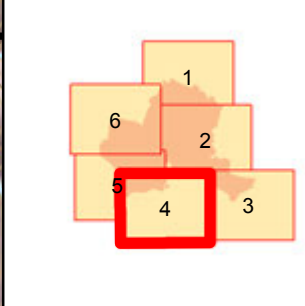
flagged deck locs used. Repair: non used deck loc needs to be rehabbed. Woody debris in intermittent stream needs removal. Finish salvage logging.

of road incl. processed logs. Repair: finish salvage logging, remove brush. Potentially use brush to cover nearby dozer line.
